OARS Biomass Summary 2022

B. Wetherill August 30, 2022

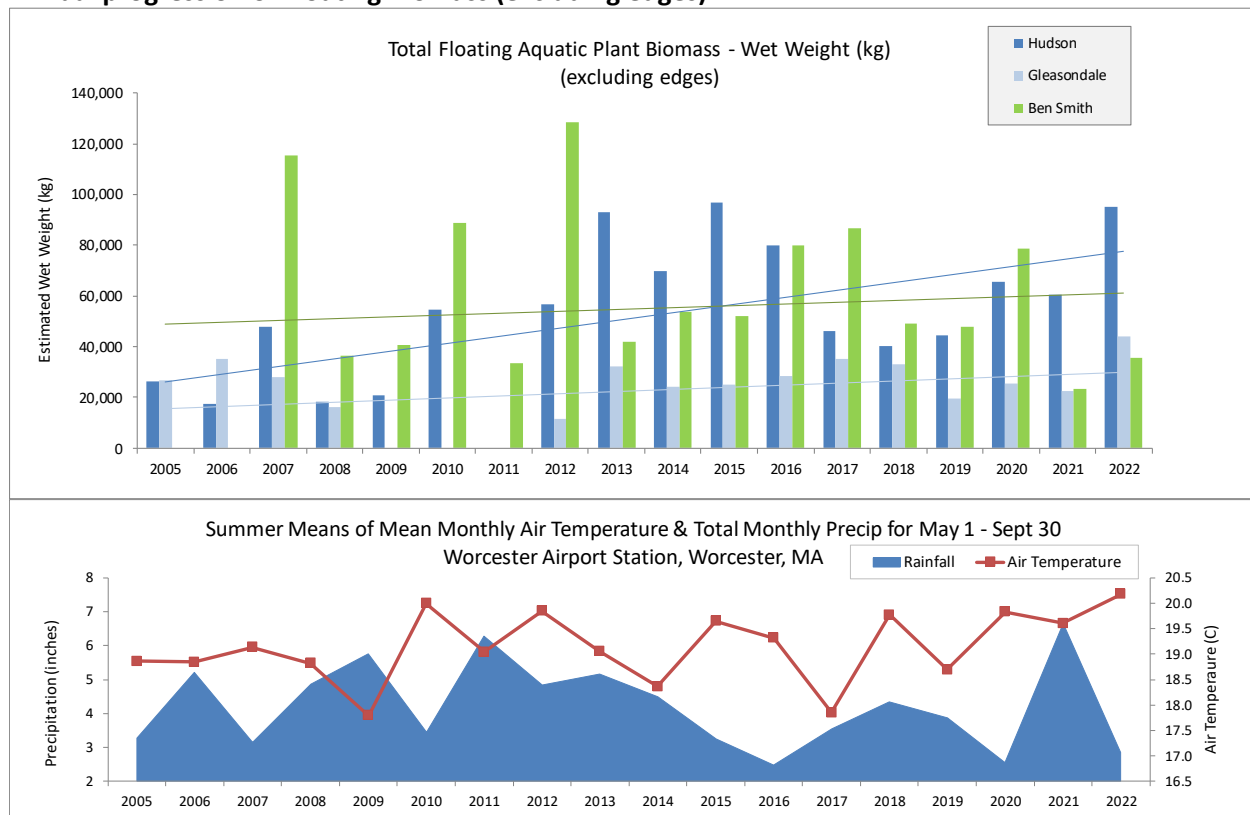
Annual progression of Floating Biomass (excluding edges)

2022 was characterized by severe drought and very warm temperatures. It was one of the three driest years since these surveys began, and average temperature was higher than any year since the surveys began. The three impoundments reacted quite differently to the extreme conditions. The Hudson impoundment was more than 60% covered on average with filamentous green algae (FGA). The Hudson impoundment is usually dominated by FGA on the surface and coontail below the surface, and conditions have been steadily getting worse since 2018. The Gleasondale impoundment also had much more floating biomass than previous years, more than it has ever had in these surveys, but it was not dominated by a single species. It had a mixture of FGA, duckweed, watermeal, and lily. The Ben Smith impoundment had much less floating biomass than previous years – surprisingly little. It looked like it might have even been treated with an herbicide. The graph below shows a continuing significant upward trend in biomass for Hudson and minimal to zero trend for Gleasondale and Ben Smith. Maps of biomass coverage in each impoundment are exhibited in Appendix A.

A statistical review of the data reveals a strong positive correlation between biomass and temperature in Hudson and a strong inverse correlation between biomass and precipitation in Ben Smith (though the Ben Smith correlation did not play out in 2022). Hudson is the shallowest of the three impoundments, which can explain the stronger effect of temperature. Gleasondale has the lowest correlations with both indicators, but there is some inverse correlation with precipitation in all three impoundments.

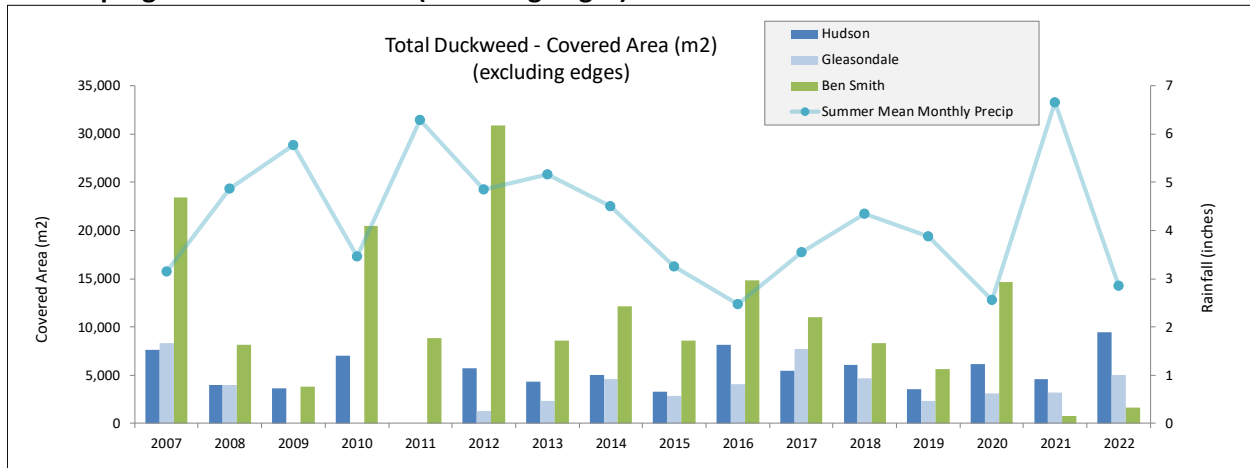
Annual progression of Duckweed (excluding edges)

A similar analysis of duckweed doesn't show any noticeable trends, though the lack of duckweed this year in Ben Smith is noticeable. Low levels in Ben Smith in 2021 were attributed to the high rainfall, but there is no clear explanation for 2022. Correlations with temperature and precipitation generally match those for total floating biomass.

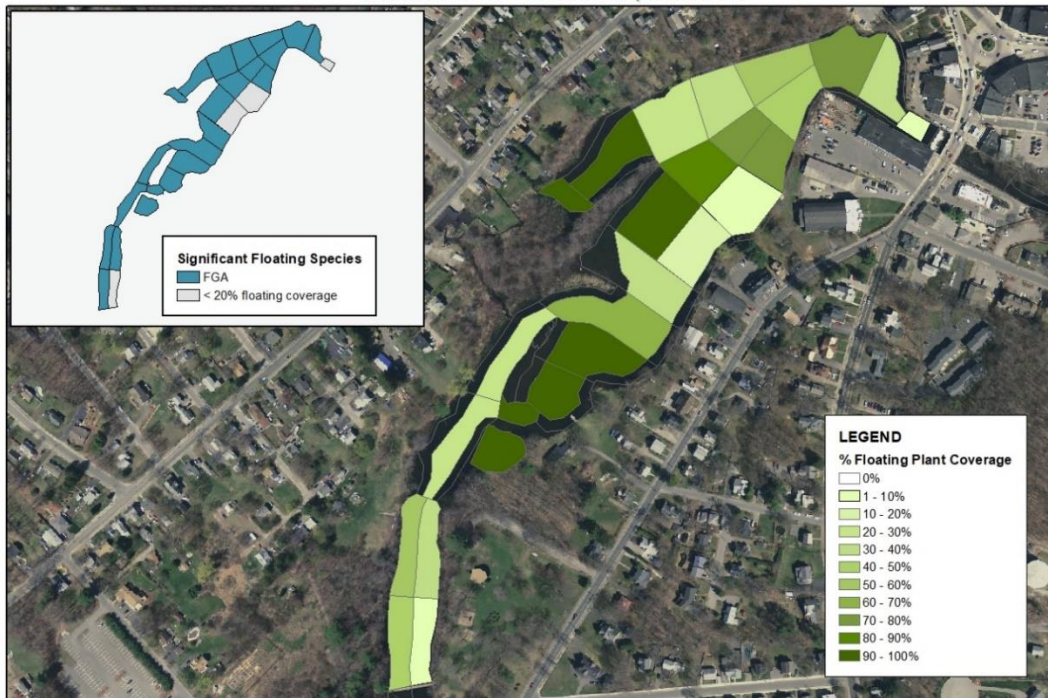
Aquatic Plant Biomass Surveys - 2022
Assabet River - Hudson Impoundment

Field observations: August 20, 2022

Note: Starting in 2020, the survey was conducted on the central areas of the impoundments only. Edges were excluded to save time. It was proposed that the real objective of the survey should be biomass in the central portion of the impoundments, not biomass that has collected along the shore. Also, the edge sectors, as drawn, included large portions of exposed land, so percent coverage was somewhat misleading. All years have been adjusted accordingly in the data. The excluded edges can be seen as a faint gray line in the maps above.

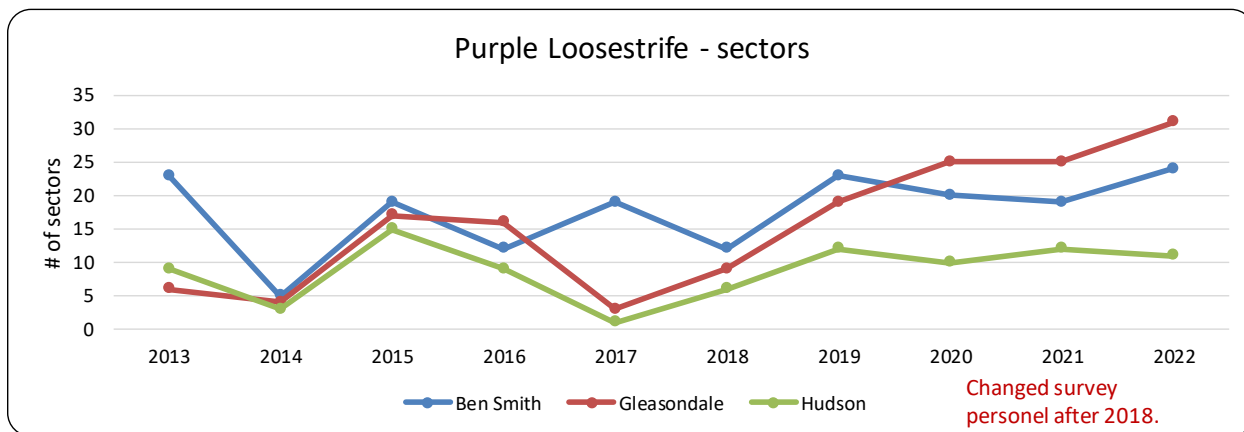
A graph by year of the number of sectors with purple loosestrife shows what seems to be an upward trend, especially in the Gleasondale impoundment. In 2022, almost all of the edge sectors in Ben Smith and Gleasondale had some purple loosestrife. Our records show that CISMA and OARS released *Galerucella* leaf-eating beetles in the Sudbury River area in 2012 (or 2013?), 2014, and 2015, but not in these Assabet impoundments.

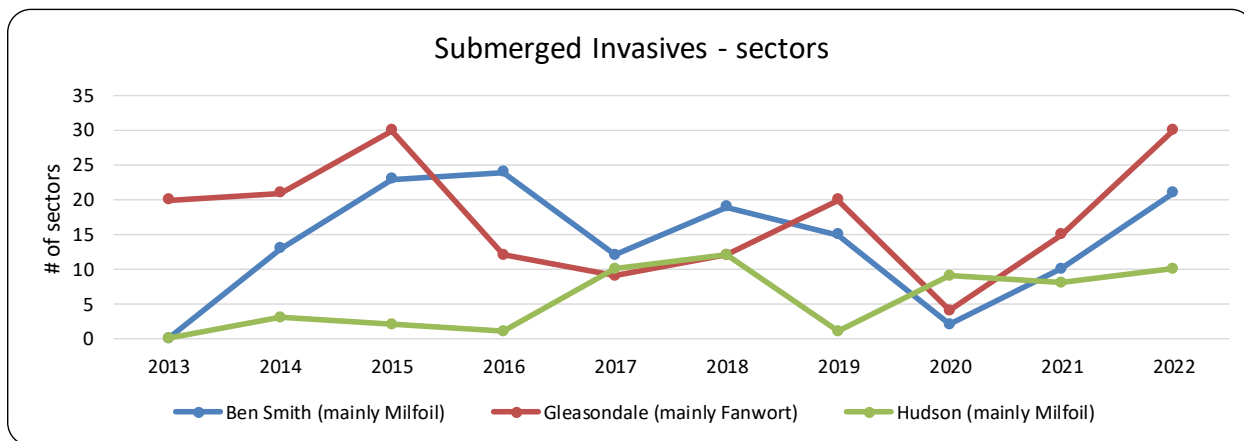
A graph by year of the number of sectors with submerged invasives shows a gradual increase in invasives in Hudson and a large spike of invasives in 2022 in Ben Smith and Gleasondale. Maps of sectors with invasive submerged species from 2014 and 2021 highlight differences between the impoundments. Gleasondale has always been distinguished by the large amount of fanwort, which is rarely seen in the other impoundments.
